FINAL REPORT

for
PALMER FIELD, PAT KIDNEY FIELD and VETERANS MEMORIAL PARK
in the
CITY OF MIDDLETOWN, CONNECTICUT

Prepared For:
CITY OF MIDDLETOWN
MUNICIPAL DEVELOPMENT COMMITTEE

Prepared By:
STORCH ASSOCIATES
engineers - architects
planners - landscape architects - environmental consultants
161 Main Street
Wethersfield, Connecticut

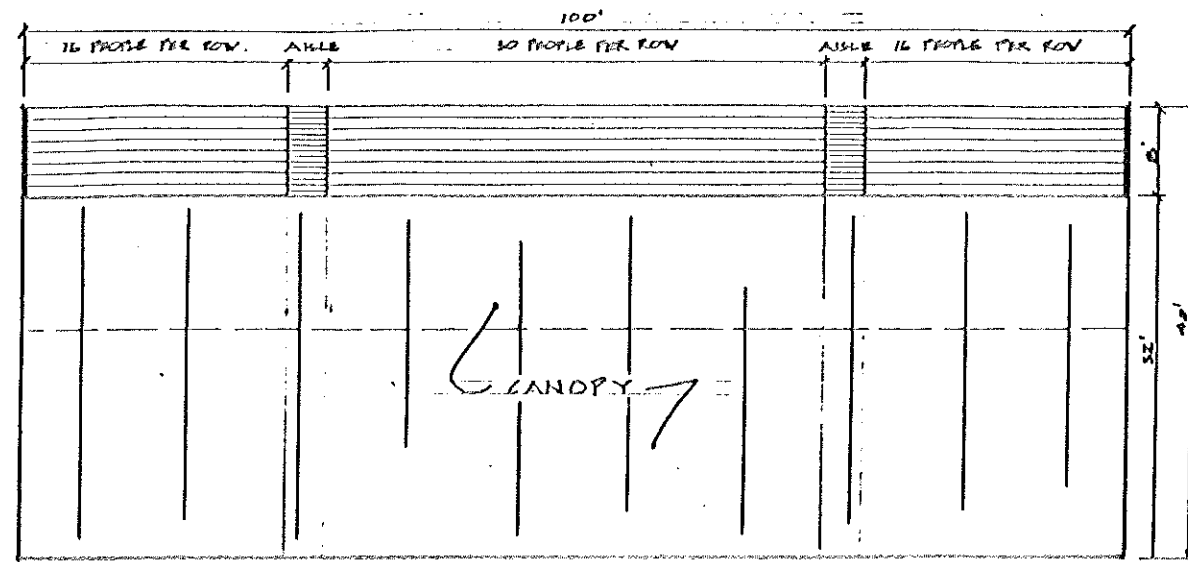
PLAN VIEW

COVERED GRANDSTANDS
